**TO OWNERS OF EXEC 162F COMPLETE KITS OR GROUP 3  
SHIPPED BETWEEN SEPTEMBER 24 AND OCTOBER 14, 2004**

**MANDATORY COMPLIANCE BULLETIN M-23**

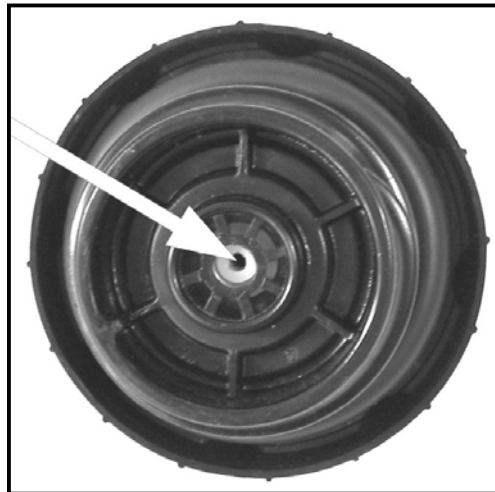
History: In the helicopter kit you recently received there is a possibility that the fuel filler caps are not properly vented. The fuel caps are packed on E25 CARD 3F in BOX C.

Action: The caps should be inspected for proper venting by verifying that there is a hole through the white plastic valve on the underside of the cap (see photo below). If there is no hole, the caps must be vented.

To vent the caps, heat a piece of welding rod or wire and push it through the center of the valve until a hole is formed all the way through the valve. Or, the caps may be sent back to RotorWay International and the modification will be done by the factory.
